On April 5, 2012, Jolene Cox, Environmental Professional at CDI, conducted a Pre-Work Site Inspection at the Subport Parking Lot for the State of Alaska, Department of Natural Resources, Alaska Mental Health Trust Land Office (TLO). The subject property is more specifically described as Lot C1, Trust Land Office Survey 2009-03, MH Parcel C20499, located with the NE $\frac{1}{4}$, SE $\frac{1}{4}$, Section 23, Township 41 South, Range 67 East, Copper River Meridian.

Photographs from the Pre-Work Site Inspection are included as Attachment 1.

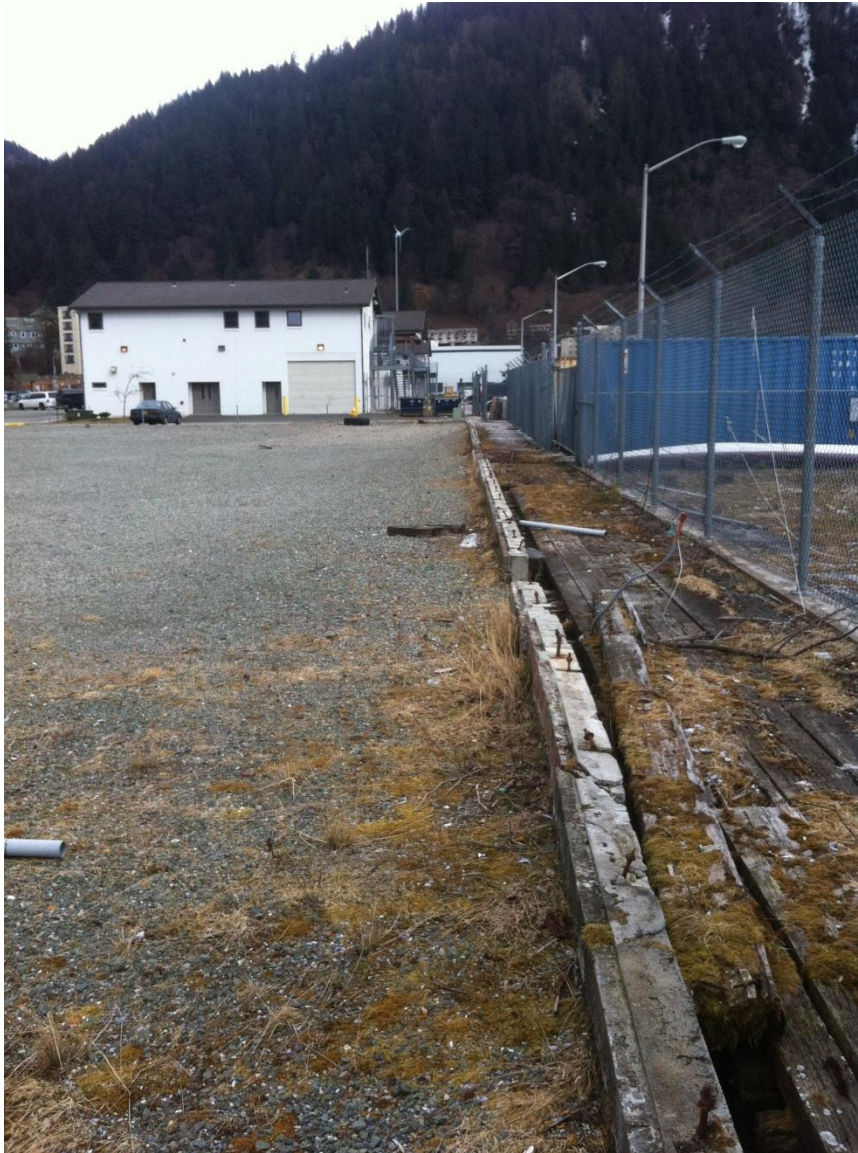
Photograph 1. Looking west along south boundary of property.

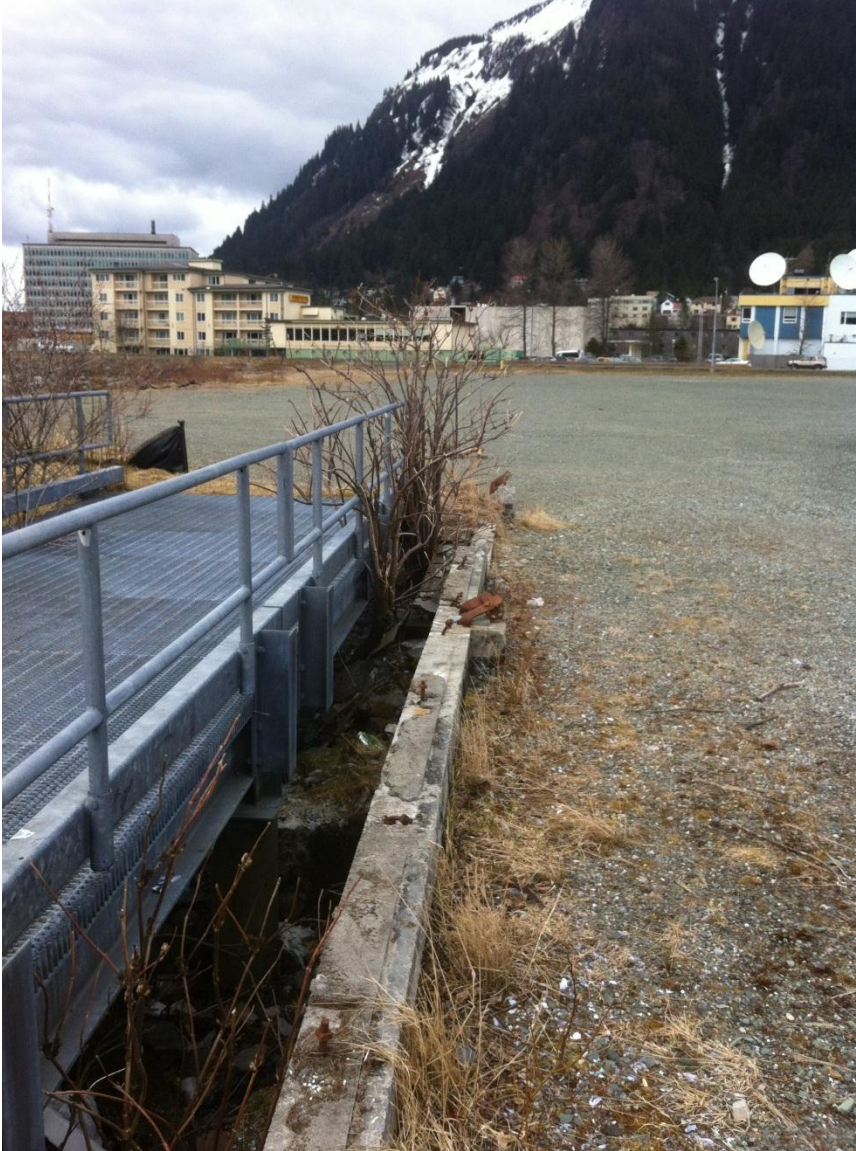
Photograph 2. Looking north from southwest portion of property.

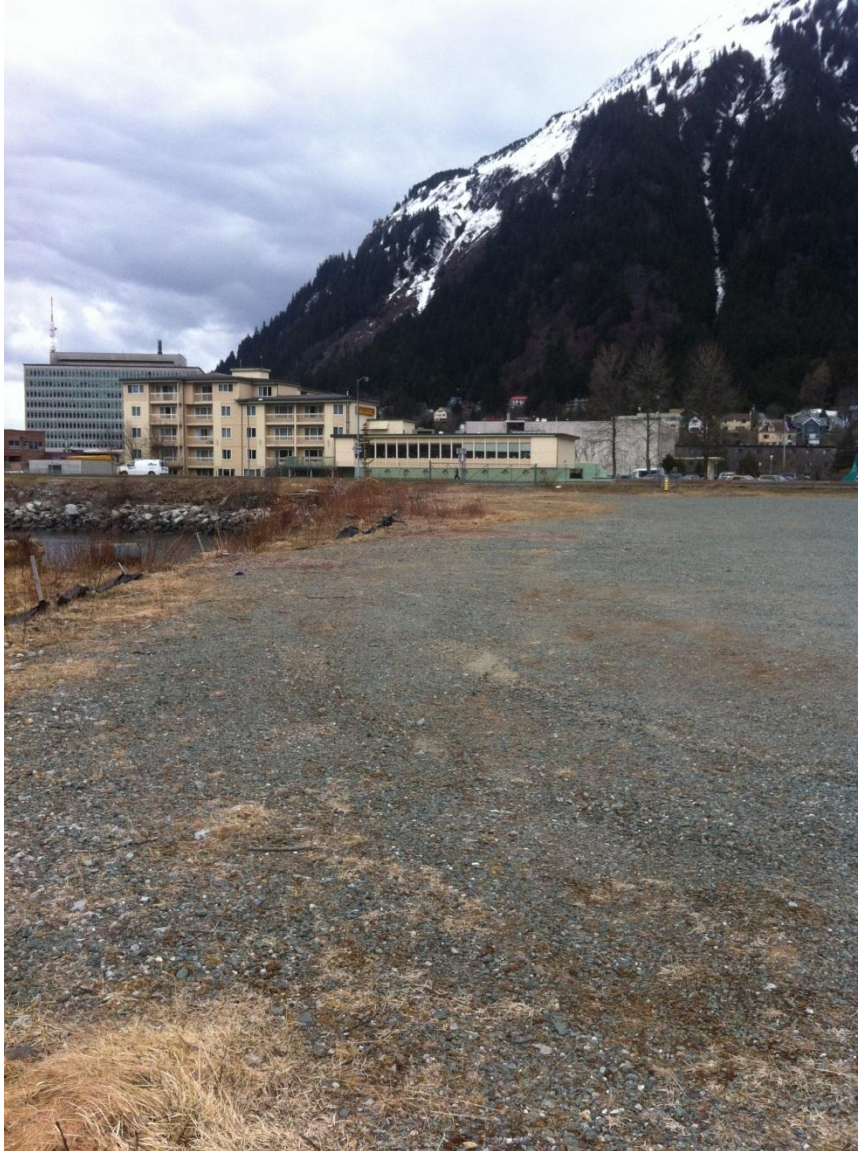
Photograph 3. Looking north along west boundary of property.

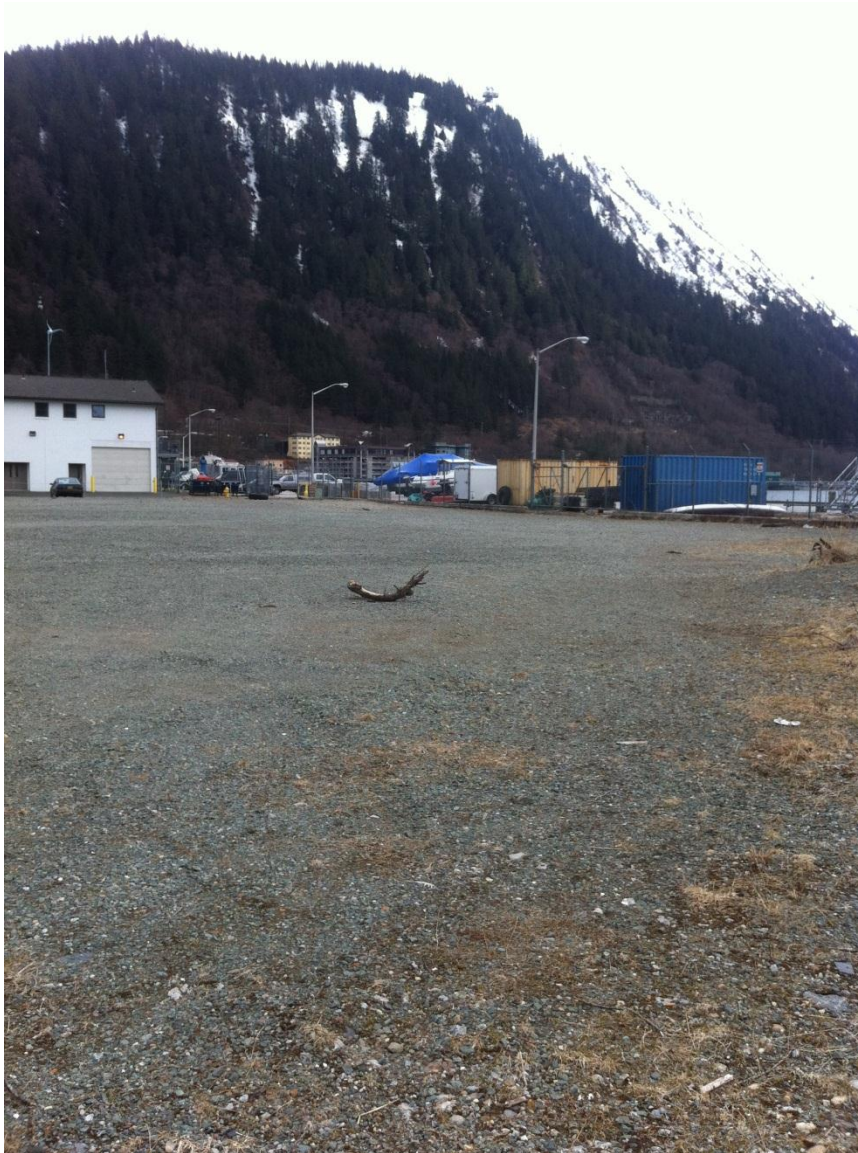
Photograph 4. View of southern one acre portion of property from the northwest.

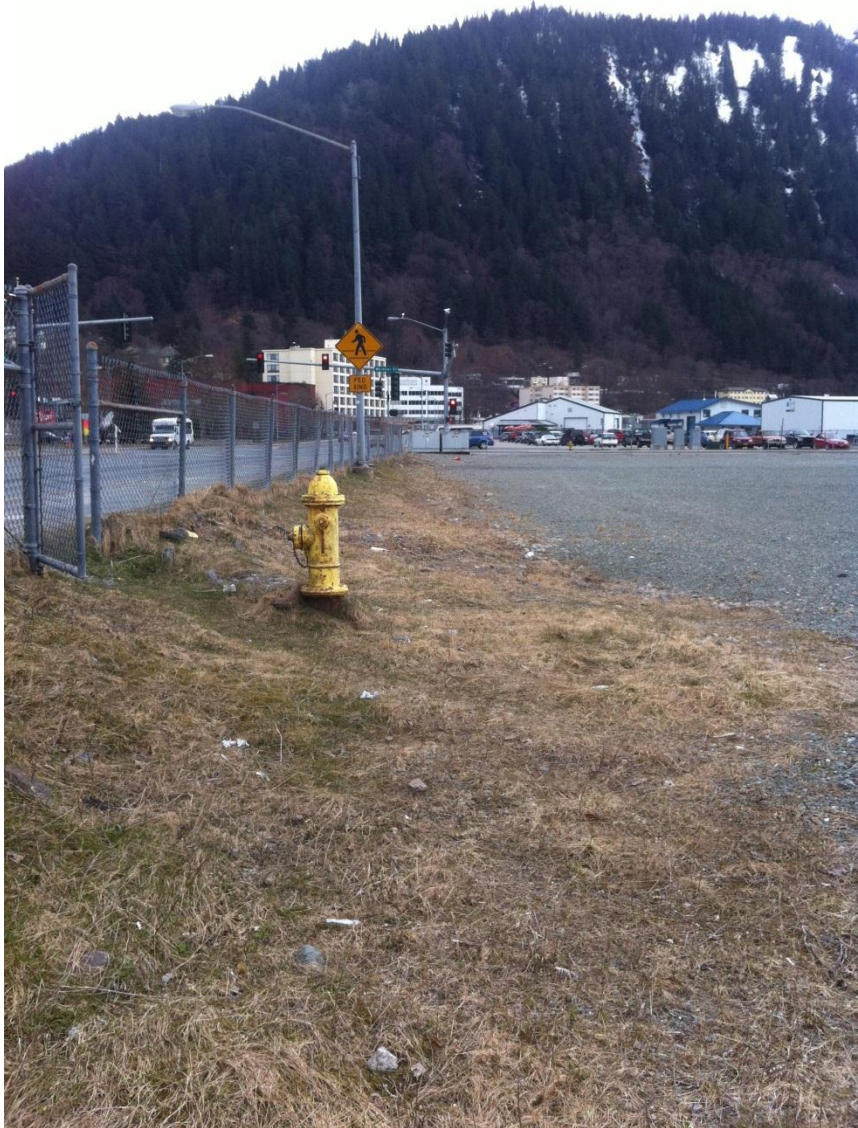
Photograph 5. Looking east along north boundary of property.

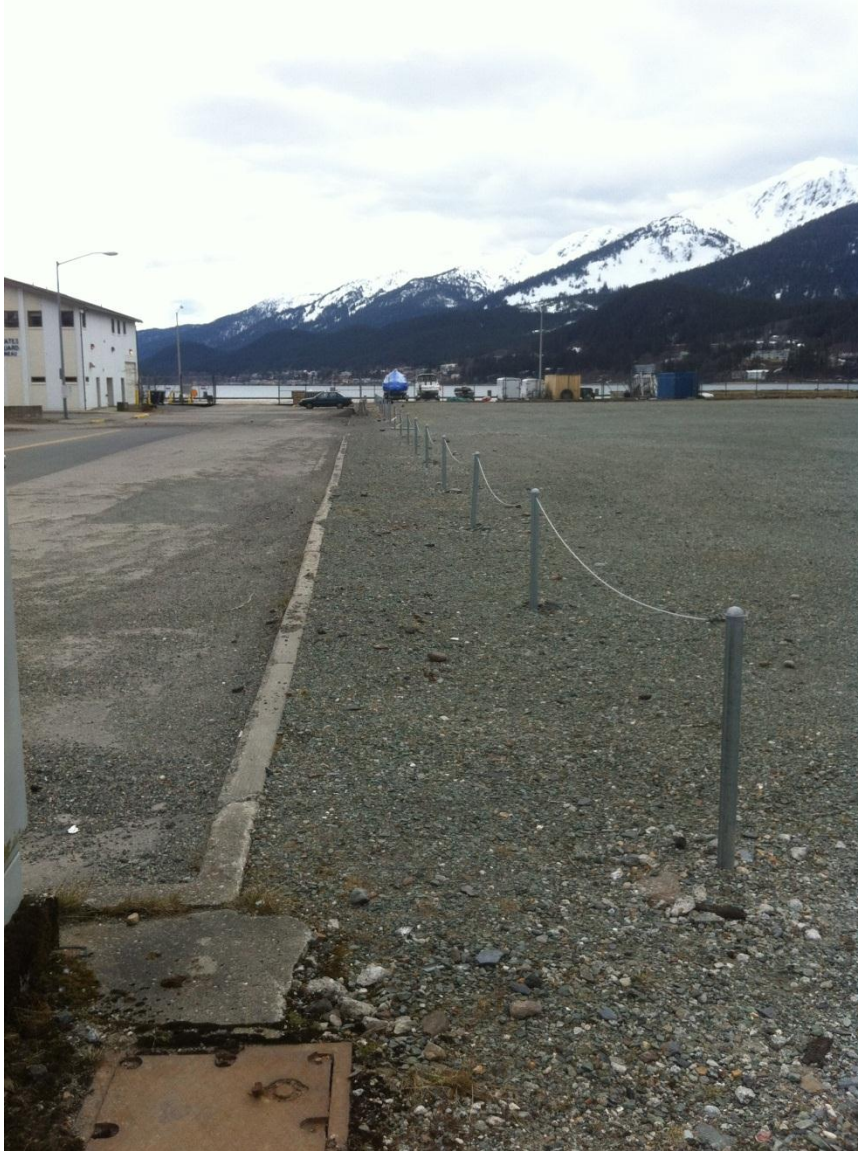
Photograph 6. Looking south along east boundary of property.

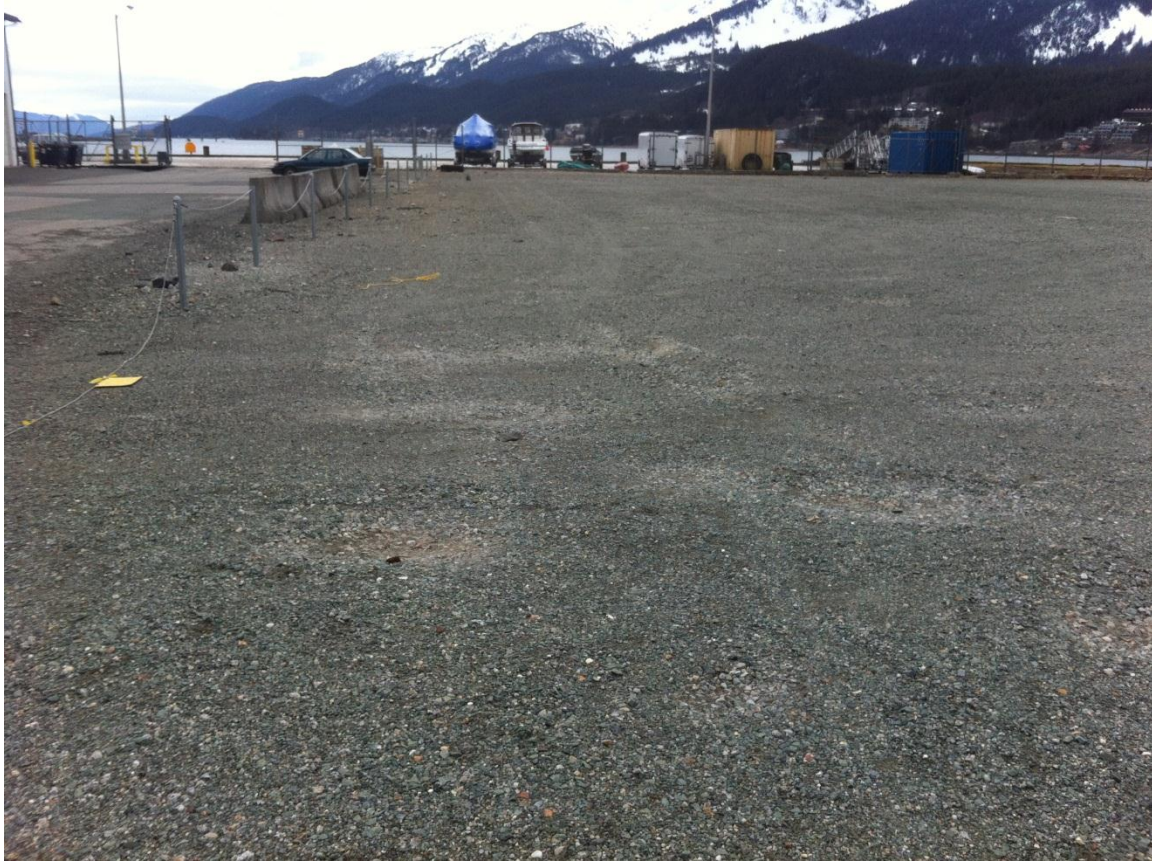
1. A series of potholes is located near the entrance/exit of the Whittier Street vehicle access.
2. A mounded area of gravel is located to the north of the Whittier Street vehicle access.
3. A deeper pothole is located in the southern portion of the property mid-site.

Photograph 7. Series of potholes located near the entrance/exit of the Whittier Street vehicle access.

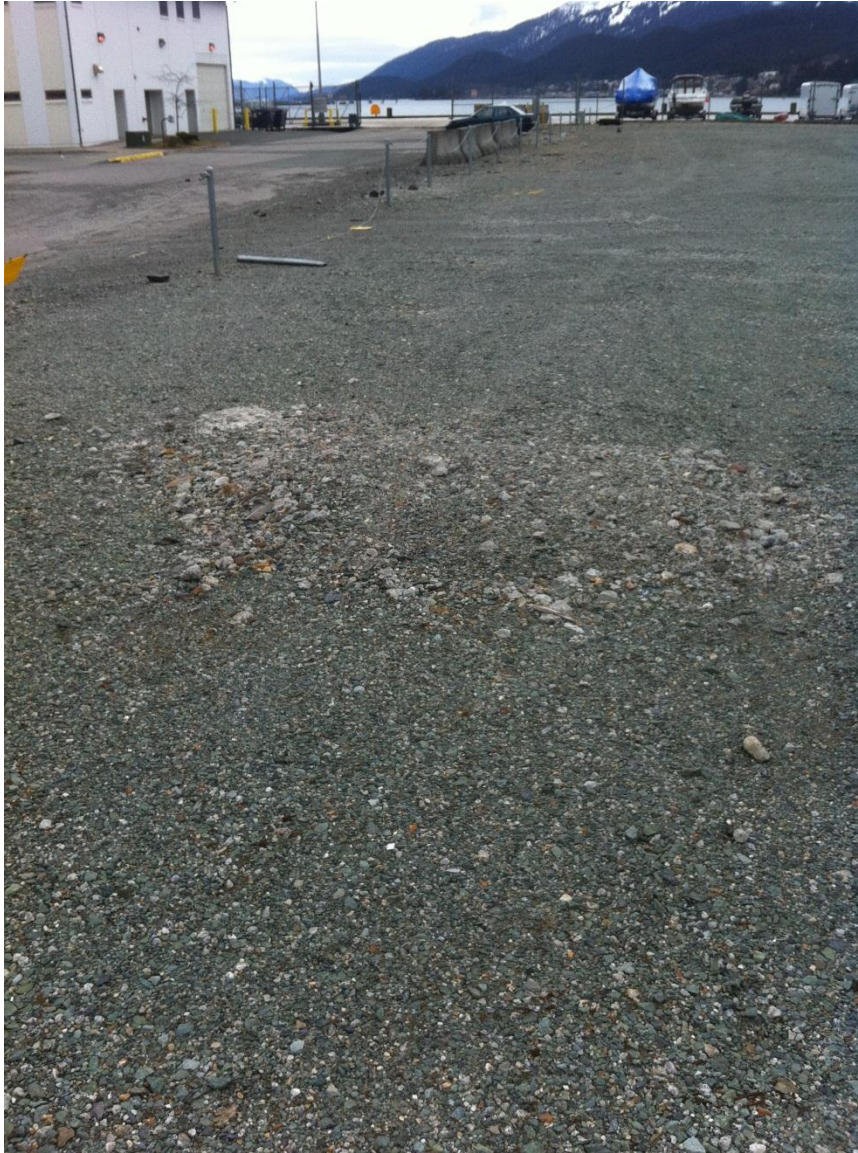
Photograph 8. Mounded area of gravel located to the north of the Whittier Street vehicle access.

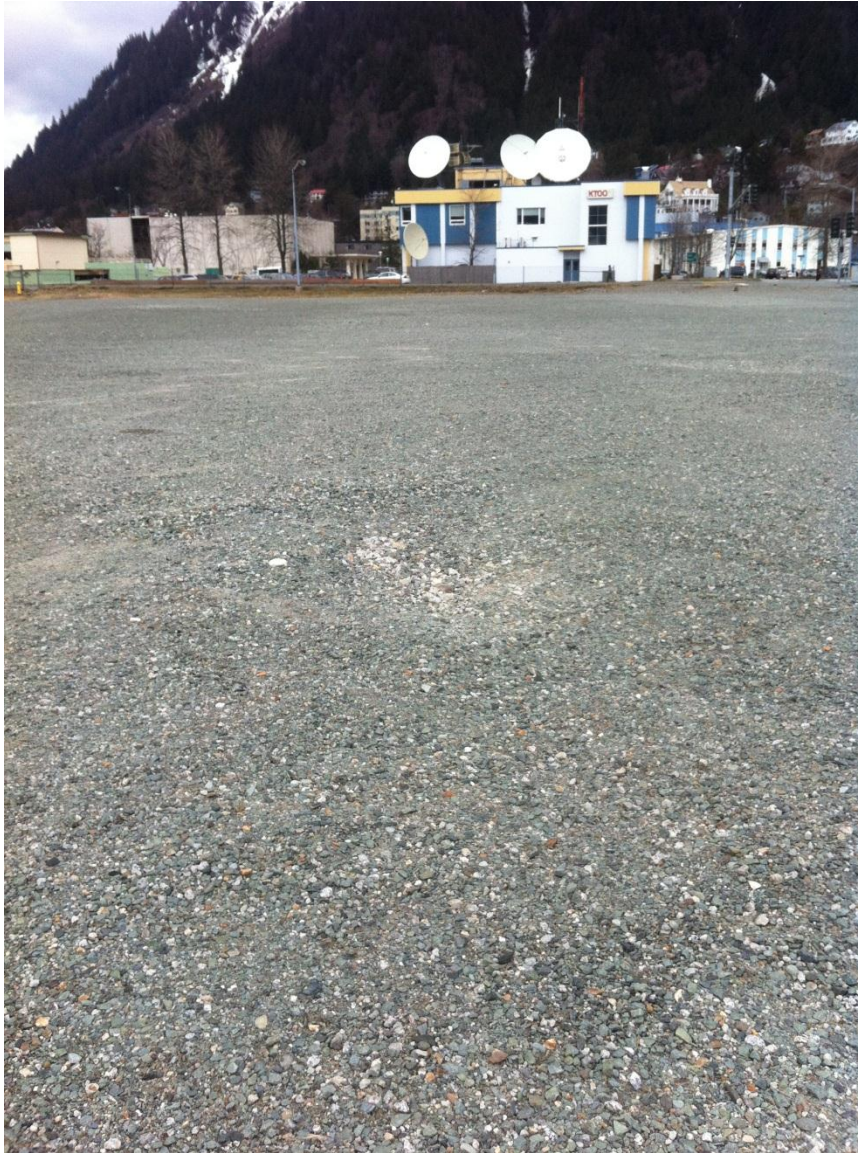
Photograph 9. Deeper pothole located in the southern portion of the property mid-site.

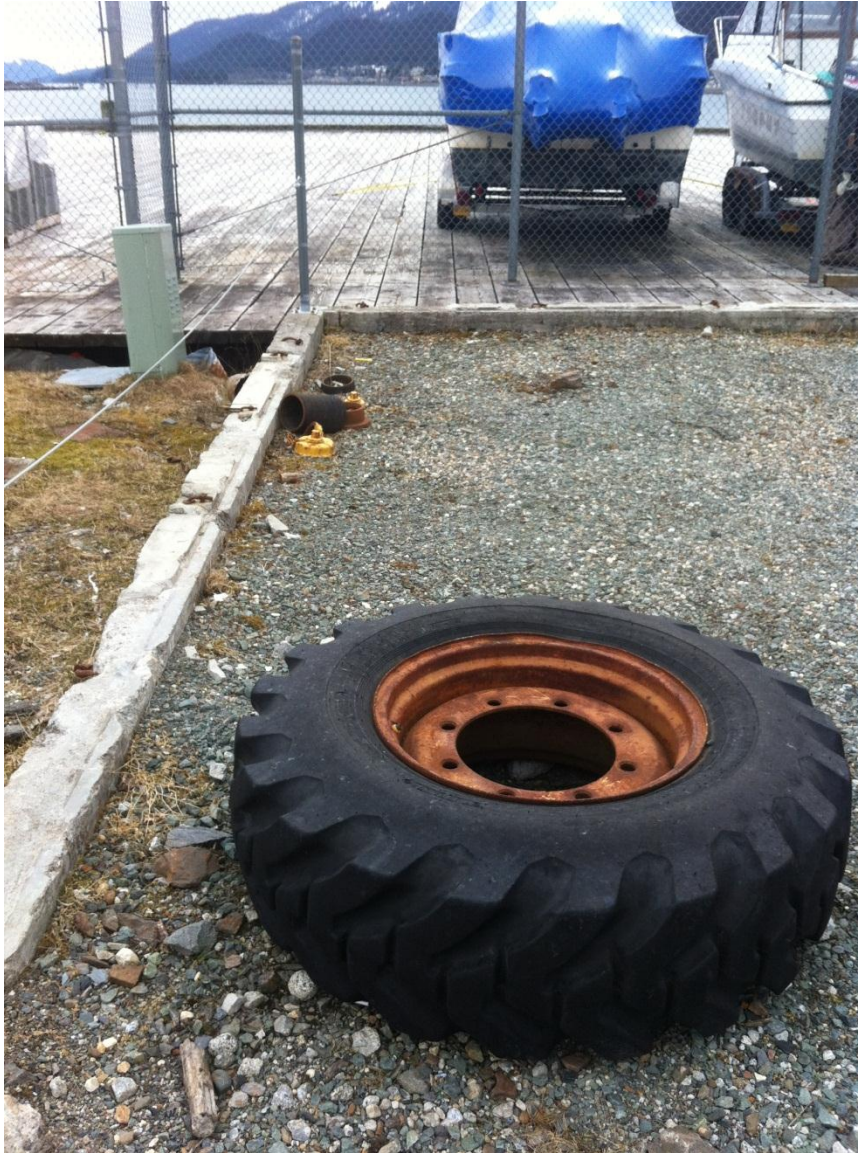
4. A vehicle tire and several pipe fittings are located at the southeast boundary.

Photograph 10. Vehicle tire and several pipe fittings located at the southeast boundary.
